Flue Gas Cleaning Sludge Leachate/Liner Compatibility Investigation

(U.S.) Army Engineer Waterways Experiment Station, Vicksburg, MS

EPA-600/2-79-136
August 1979

Interim Report

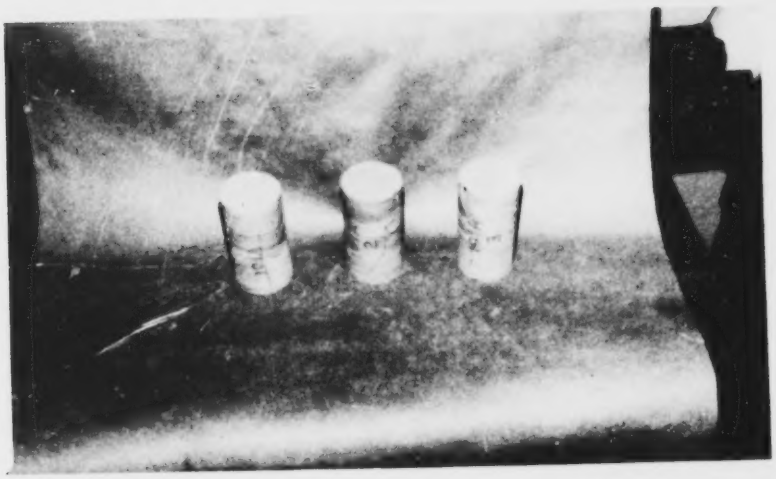
a. Portland cement

Figure 15. Admix liner materials following 12 months of inundation and unconfined compression test.

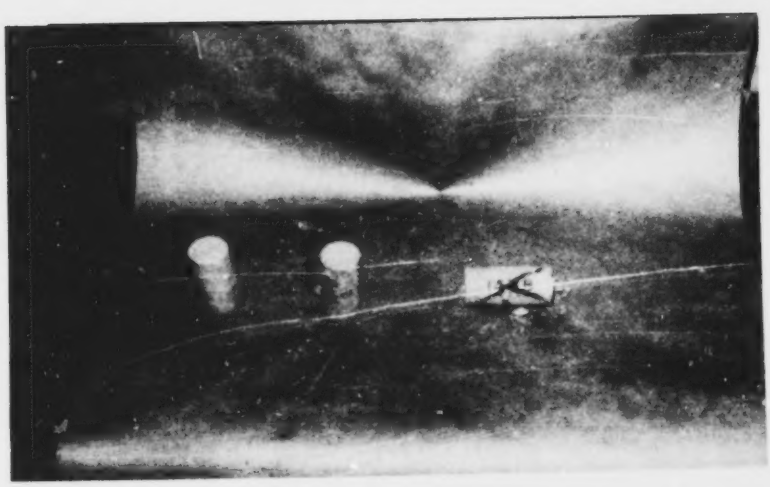
b. TACSS 020

TACSS 020 and 025 both suffered 5 to 25 percent decrease in UC, which would seem to indicate some degree of susceptibility to continuous exposure that could only be expected to get worse with time. Much more can be determined when the 24-month test results are analyzed.

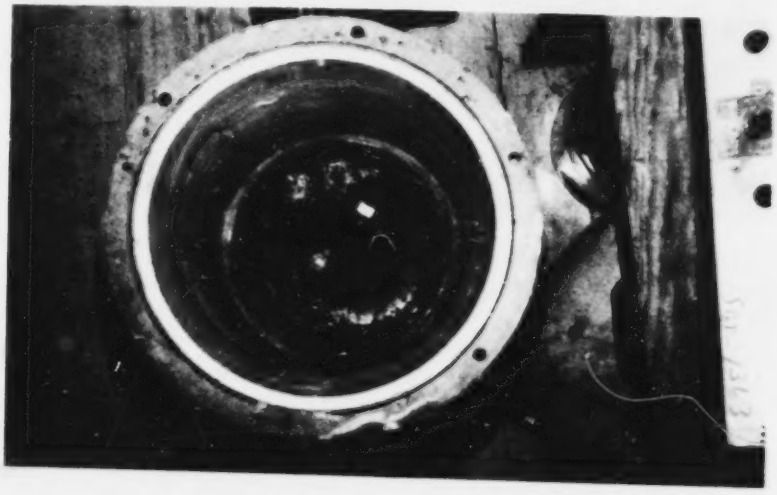
A photo series (Figures 16, 17, and 18) of the asphaltic concrete liner shows two extensive surface cracks (Figure 16). Covering the liner with water and applying back pressure only produced bubbles at the intersection of the two cracks (Figure 17). A close-up of this liner shows the relative size of the two cracks (Figure 18).

Figure 16. Asphaltic concrete liner surface showing extreme cracking.

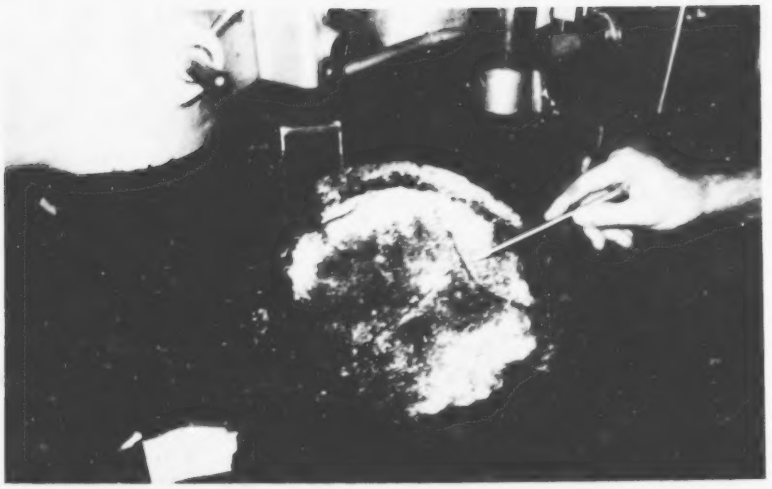
Figure 17. Asphaltic concrete liner with sludge removed, approximately 1-in. water added, and 2-psi back pressure applied.

Figure 18. Close-up of cracks in asphaltic concrete liner. Discolored area around periphery indicates area covered by silicone sealant.

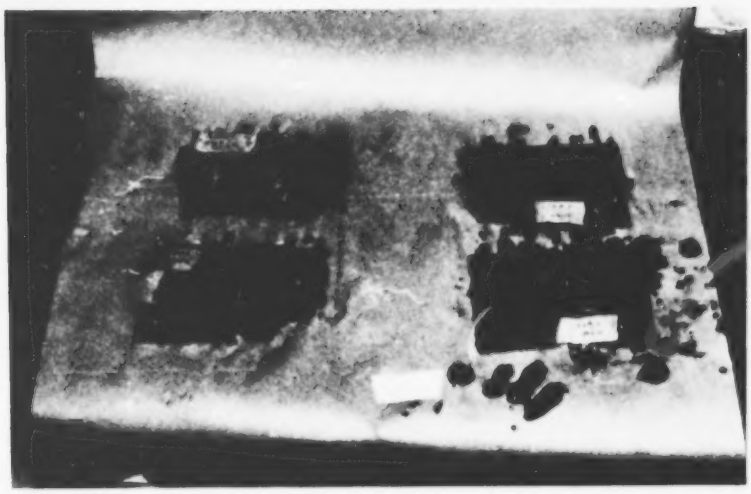
a. DCA-1295

Figure 19. Spray-on liner materials samples following 12 months of inundation and grab test.

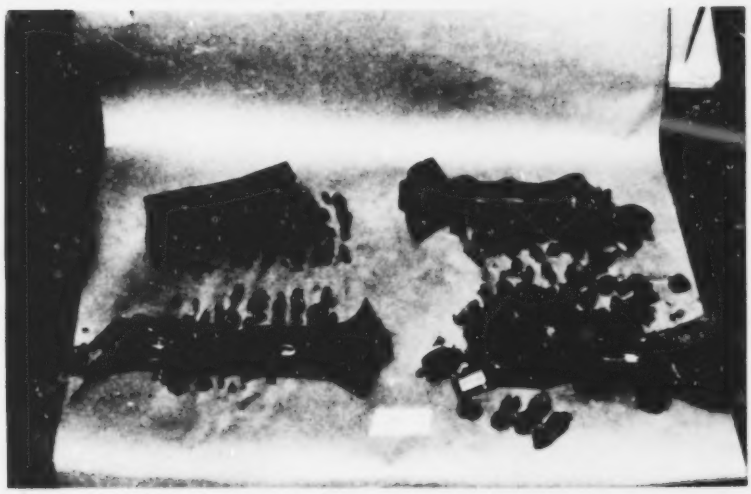
Figure 20. Prefabricated membrane total liner material samples following 12 months of inundation and grab test.

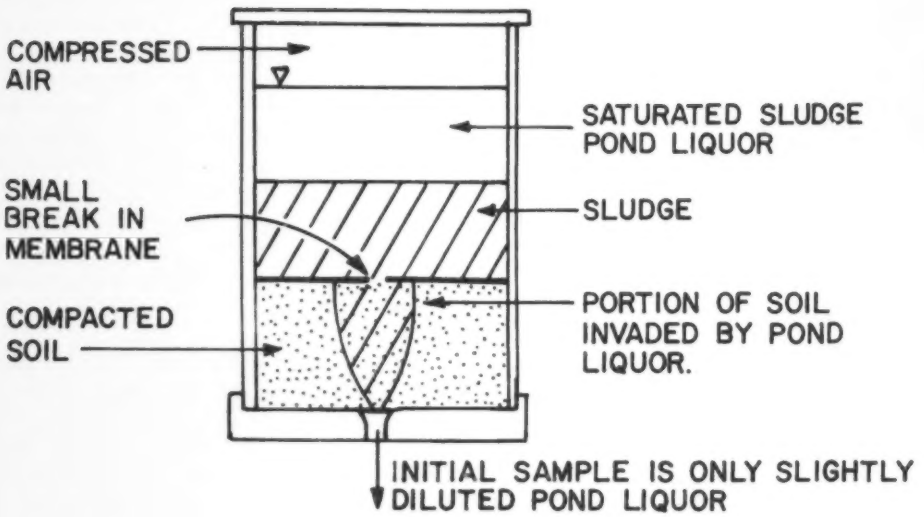
a. Small rupture in membrane.

COMPRESSED AIR
SATURATED SLUDGE POND LIQUOR
SMALL BREAK IN MEMBRANE
SLUDGE
COMPACTED SOIL
PORTION OF SOIL INVADED BY POND LIQUOR.
INITIAL SAMPLE IS ONLY SLIGHTLY DILUTED POND LIQUOR

Figure 21. Pattern of leakage from membrane ruptures.

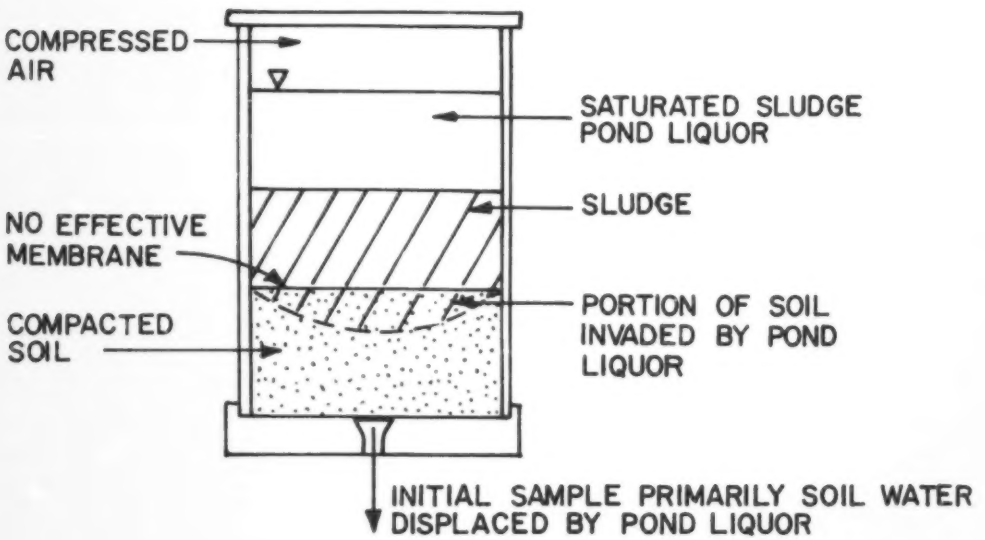
b. Large rupture in membrane.

COMPRESSED AIR
SATURATED SLUDGE POND LIQUOR
SLUDGE
NO EFFECTIVE MEMBRANE
COMPACTED SOIL
PORTION OF SOIL INVADED BY POND LIQUOR
INITIAL SAMPLE PRIMARILY SOIL WATER DISPLACED BY POND LIQUOR
